## TOWN OF NORTH SALEM

Office of the Supervisor

September 7, 2021

You requested some information from us about the drainage from Peach Lake in heavy rain events. I have put together several pages outlining the issues we have. I have included YouTube videos that we have taken recently and one from a couple of years ago which show some of the water level concerns.

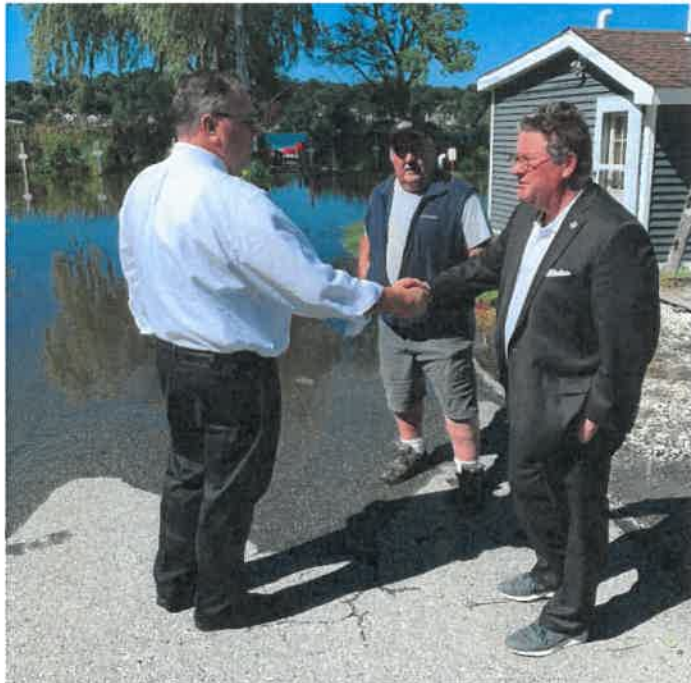
Figure 1 Recent flooding at Pietsch Coop at the southern end of Peach Lake due to Storm Ida on 9/1/21. Warren Lucas, Senator Harckham and Pietsch Coop President Jim Bohren. Southeast received a \$125,000 grant from the Senator to be put towards addressing the Cobb Road drainage issue.

The picture above is from September 1, 2021 showing the impact of Tropical Storm Ida to the low lying Pietsch Coop residences in North Salem which is about 1.75 miles south of Cobb Road. About 15 homes are subject to flooding based on the severity of any individual storm. In the Town of Southeast a number of homes along Peach Lake Brook in Starr Ridge Manor also have property flooding issues.

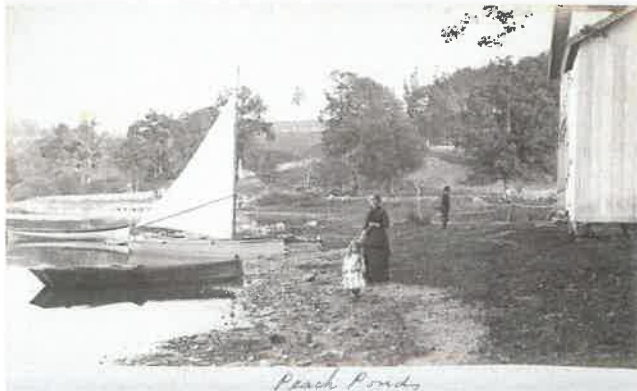
**Figure "Peach Ponds" dated 1884. A picture of the South end of Peach Lake. To the right is the Lakeside Field Club, beyond that to the left is Pietsch Garden Coop. The building foundation of the barn, east of Lake Side Field Club is at that location and inundated with water. This was after the digging of Peach Lake Brook and lowering of the lake level by NYC.**

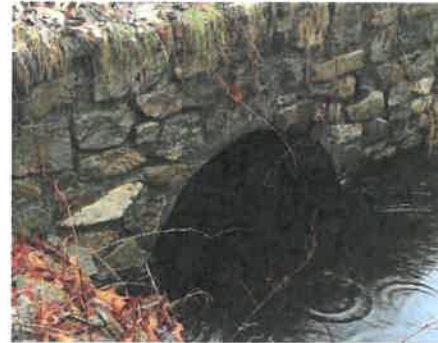
Quite a number of years ago, the Town of Southeast put a new pipe under Cobb Road, the pipe was not sized properly for the volume of water that had to exit the lake during heavy rain events. This was likely done without realizing that it was the only exit for all of the water entering the lake. All 850 acres of the storm basin of Peach

Lake must flow through the 30 inch "D" shaped pipe to exit the lake. Just one inch of water in the Lake's stormwater basin equals 23 million gallons and when things are saturated a majority of that water flows into the lake. One inch of rain in the stormwater basin can raise the lake 3.5 inches and the water now takes days to exit the lake due to Cobb Road pipe.

Figure 2 Existing pipe under Cobb Road

A second issue is that the upstream bottom of the "D" shaped pipe under Cobb Road is also about 8 inches higher than the bottom of the stream effectively creating an 8 inch dam which has the effect of keeping the lake higher. The 1890's small cement dam on Peach Lake Brook (near the sewage treatment plant) has been perpetually under water due to the height of the water in the book almost certainly because of the Cobb Road drainage pipe height.

5. There are other items we are considering but the biggest issue we believe is the drainage under Cobb Road. This drainage limits the outflow to about 10,000 gallons per minute. North Salem has been requesting that Southeast look into this since about 2014. Our request to Southeast was that the current pipe be removed and a wider and lower conveyance be put in which will allow the lake to attain its historical level and also drain faster in severe rain events. The existing 1890's dam can then be used during conditions to better control the level of the lake.

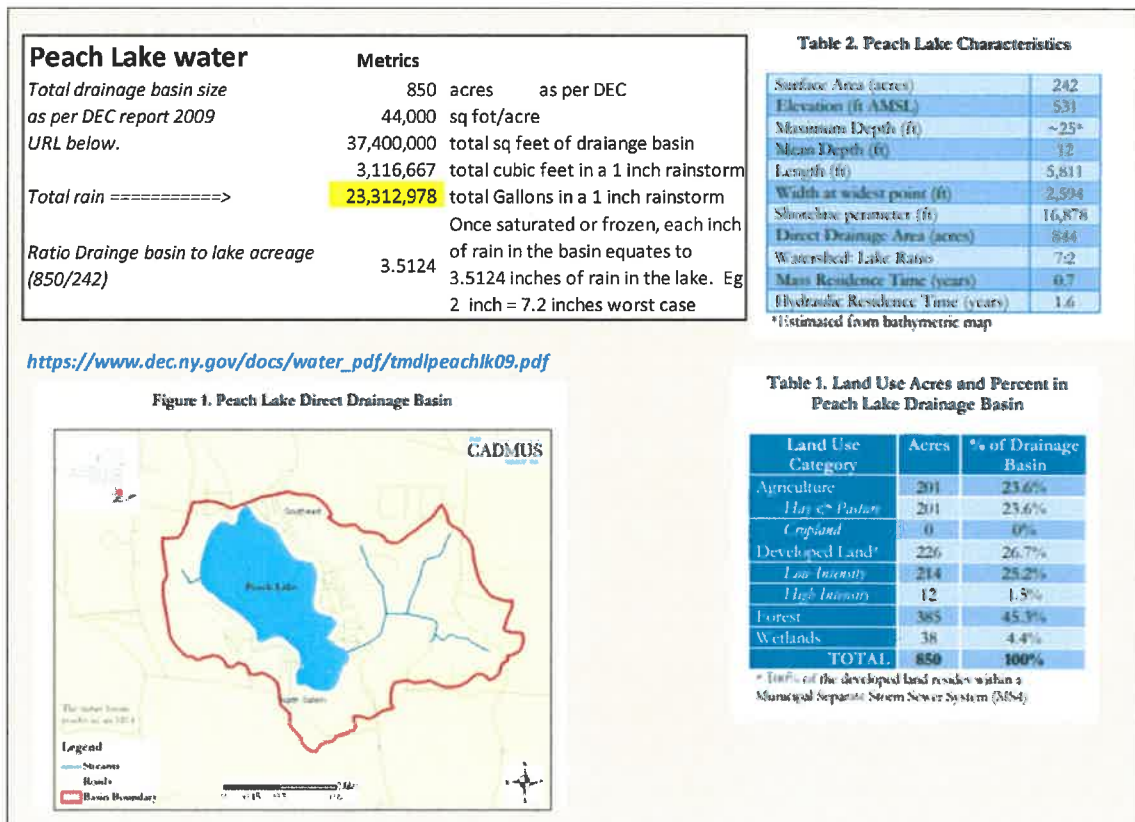
Figure 3 Rain volumes and also information about Peach Lake drainage basin, the later from the 2009 Camdus Report done by the NYS DEC [https://www.dec.ny.gov/docs/water\\_pdf/tmdlpeachlk09.pdf](https://www.dec.ny.gov/docs/water_pdf/tmdlpeachlk09.pdf)

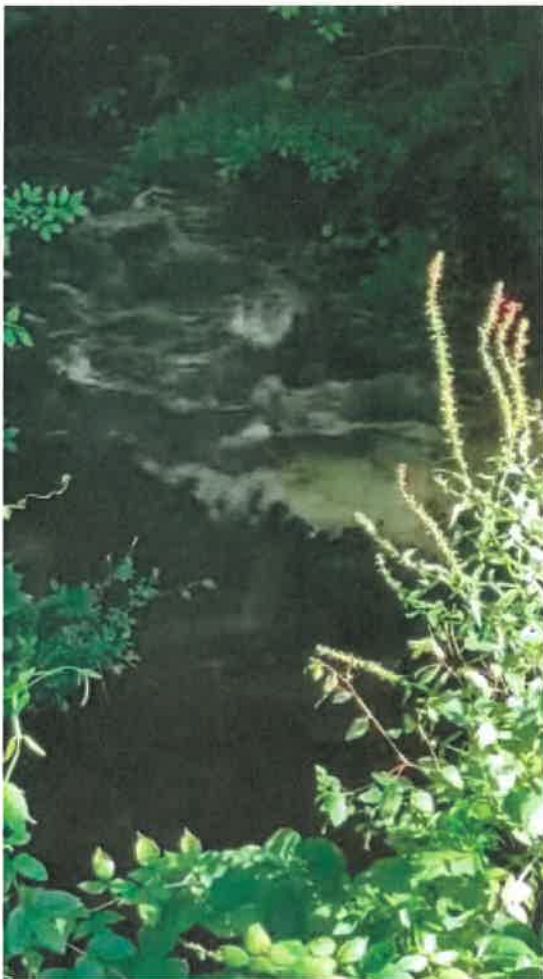
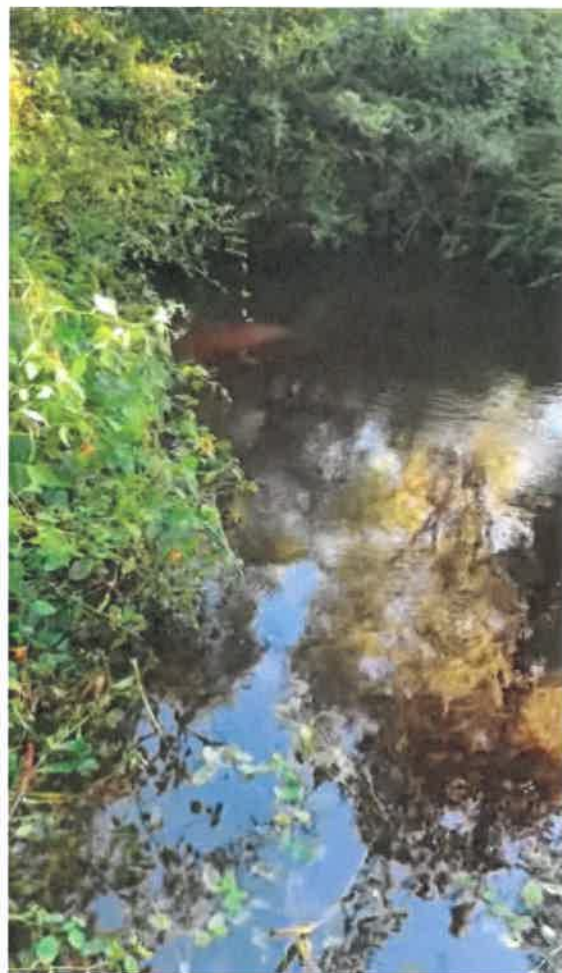
The left picture shows the water exiting the pipe, the right picture shows the water ponding against Cobb Road before entering the pipe with little or no turbulence. The water was over the channel banks as can be seen in the video. This was taken the morning after Tropical Storm Ida, 9/1/2021.

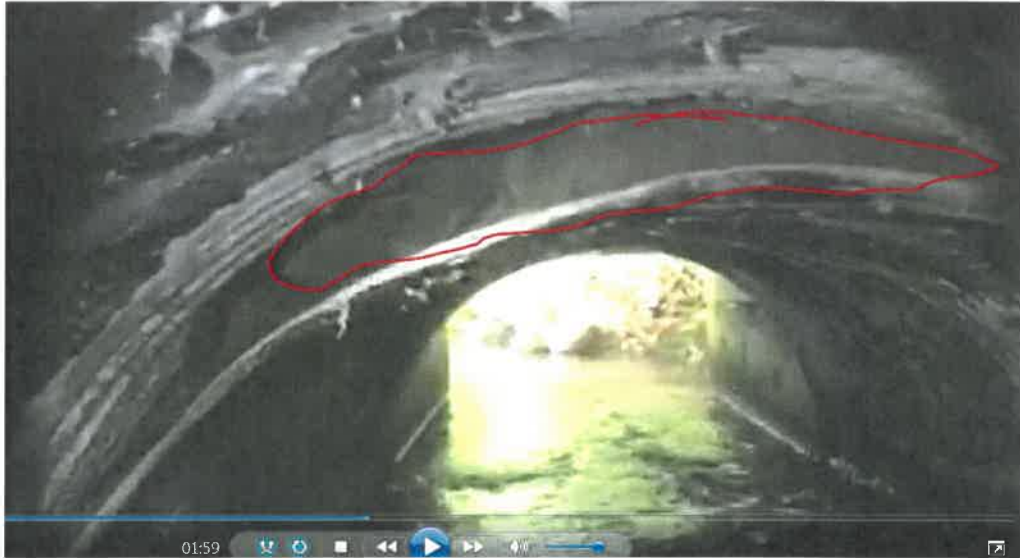
**Figure 6** The outlet does not fit the pipe properly causing far more turbulent flow and reducing the pipes discharge/flow capacity. The video is available on YouTube at <https://youtu.be/Xs9bldTbMPE> .

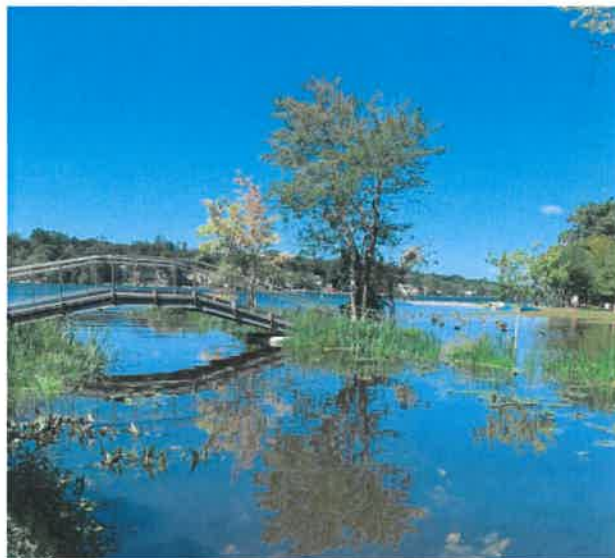
The area around the lake is serviced by the Peach Lake Sewer district run jointly by Southeast and North Salem. The Pietsch Coop sewer line along Cottage Lane is run through a number of manholes which collect sewage from 32 homes. Two of the manholes were under water for several days during Tropical Storm Ida and previous severe storms. Special work was done last year after Isaias raising the tops of the manholes (and the section of the parking lot they are in) by several inches higher to keep them above any flood waters and at the time we also made sure the tops were sealed against rain water, however, when the lake level rises in a bad storm the manholes are covered with 8 inches or more of water and the infiltration of lake water into the sewer system is unstoppable and significant and the pumps run for the majority of each day attempting to send the 'sewage' to the plant. As can be seen in this report from last week the pumps ran for almost 1,100 minutes of the 1,440 minutes in a day or 76% of the day trying to keep ahead of the lake water infiltrating the system. In previous storms this burned out pumps which we were unable to fix as there was no way to access them under the lake water until the levels subsided.

Figure 9 Picture of recent flooding in area with the sewer manholes. Picture taken by Senator Harckham's staff.

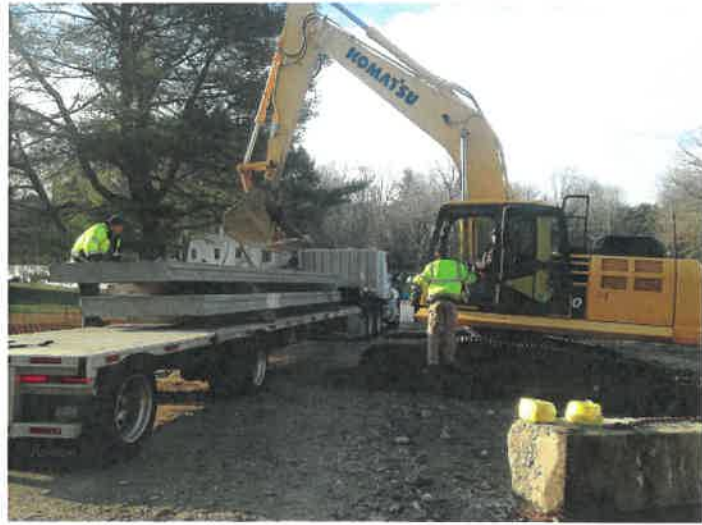
Figure 10 The bridge abutments were finished and the prefabricated decking was installed using a Town excavator which reduced the cost to the contractor, Contech.

Lastly with regards to the existing bridge, if the Town decides to create a bridge over the stream 20 feet or more in size the NYS DEC will be involved which will greatly increase its price. The Town of North Salem rebuilt its town bridge on Valeria Circle which spanned a DEC trout stream. While the situations are different we would expect Southeast to be able to construct a bridge less than 20 feet long which would meet or exceed any constraint the Town of North Salem would have. The Town of North Salem originally borrowed \$200,000 for the bridge work in 2015 but did not spend the entire amount. The bridge abutments were completely rebuilt and the decking came in prefabricated. You can also use prefabricated supports which we looked at but did not use. Please have your engineer talk to Jim Hahn at Hahn Engineering. Any help he can provide we would be happy to support.

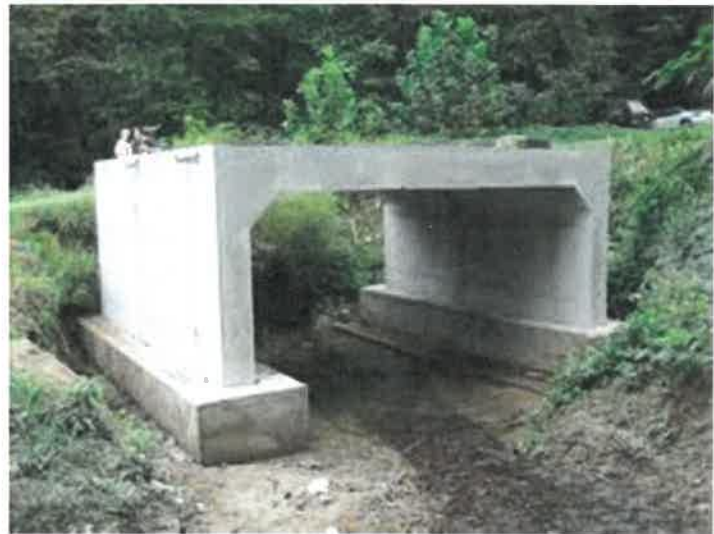
Figure 11 A unit like this can also be used, prefabricated/ prestressed concrete. We looked at this as an option.
